Fuel leakage

– from high-pressure pipes and low-pressure circulation lines

SL2020-707/KNB
December 2020

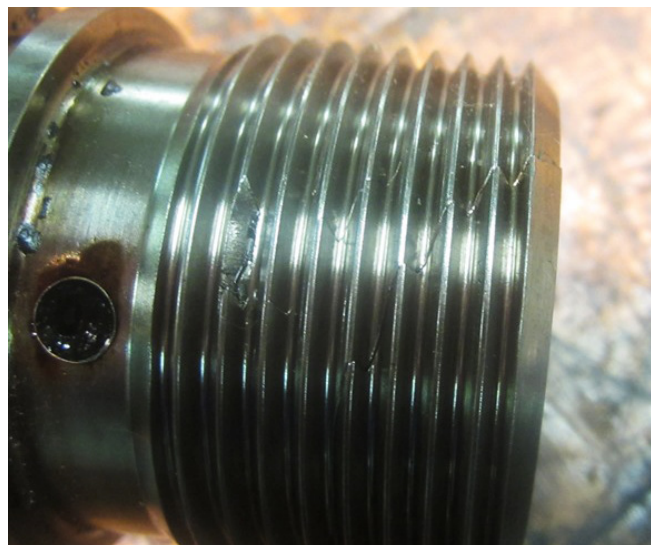
Cracked fuel oil pipe nipple

An oil leakage should under no circumstances be remedied by retightening the union nipples.

The fuel pipe must be dismantled, cleaned, and checked visually for damage on the seating surfaces (conical seats), and the union nipple must be examined for cracks or seizure marks, especially around the threads.

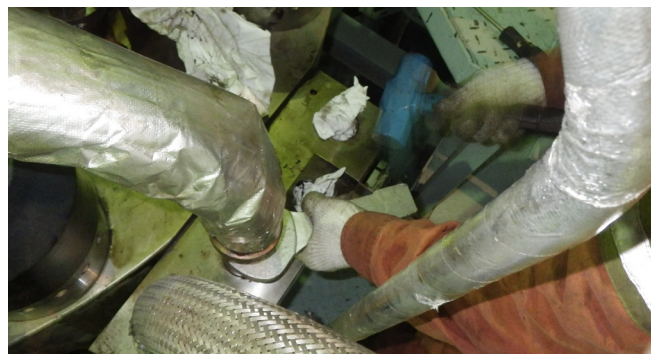
Unauthorised tightening by means of a wrench and a hammer

- It is highly important to follow the mounting and tightening procedure stated in our instruction book, instruction no. 4265-0101.
- When parts have been cleaned and inspected properly, the pipe must be tightened using the correct torque.
- In case of a leakage, the parts must be disassembled, cleaned, and inspected before a new attempt to re-assemble is carried out.
- In our experience, the risk of a crack developing increases if a union nipple just once has been tightened in an unauthorised way by means of a wrench and a hammer. In such a case, we recommend exchanging the union nipples at the first opportunity.
- We refer to the expected lifetime of the complete high-pressure pipe (including the union nipple) as stated in our Service Letter SL2019-681.

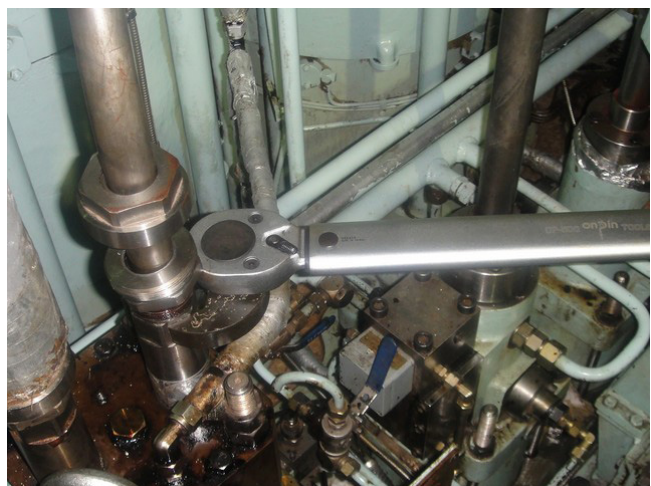
Torque wrench high-pressure fuel pipe
