Fuel leakage

– from high-pressure pipes and low-pressure circulation lines

SL2020-707/KNB
December 2020

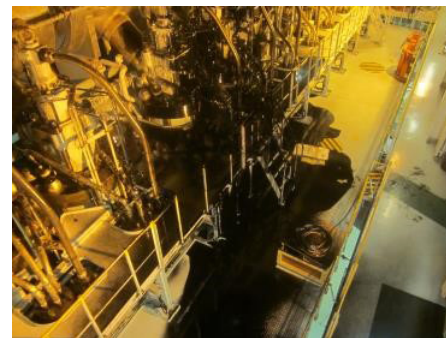
In some of the cases, the oil leakage was related to cracks in the union nipple that fastens the fuel oil pipe to the fuel booster/pump. In other cases, a large fuel oil leakage from the low-pressure circulation line has been reported.

Cracked fuel oil pipe nipple

An oil leakage should under no circumstances be remedied by retightening the union nipples.

The fuel pipe must be dismantled, cleaned, and checked visually for damage on the seating surfaces (conical seats), and the union nipple must be examined for cracks or seizure marks, especially around the threads.

If damage is found on the conical seating area on the high-pressure fuel pipe, the conical part must be dressed up according to the instruction book, instruction no. 4265-0101.

- It is highly important to follow the mounting and tightening procedure stated in our instruction book, instruction no. 4265-0101.
- When parts have been cleaned and inspected properly, the pipe must be tightened using the correct torque.
- In case of a leakage, the parts must be disassembled, cleaned, and inspected before a new attempt to re-assemble is carried out.
- In our experience, the risk of a crack developing increases if a union nipple just once has been tightened in an unauthorised way by means of a wrench and a hammer. In such a case, we recommend exchanging the union nipples at the first opportunity.
- We refer to the expected lifetime of the complete high-pressure pipe (including the union nipple) as stated in our Service Letter SL2019-681.
