New procedure for honing of cylinder liners

SL2021-710/JNN

March 2021

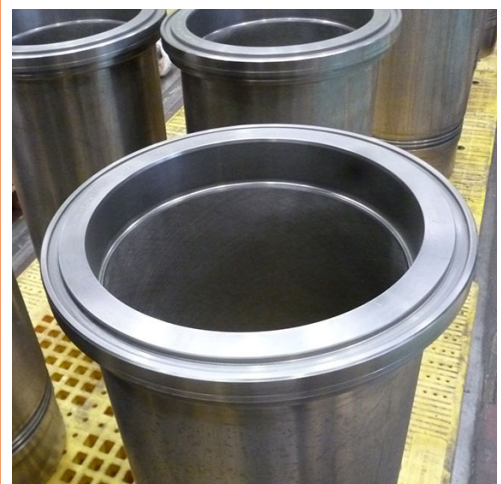
Work step	Set-up and mode of honing operation MAN Energy Solutions

Honing Stone Type	Settings		
		Speed	Pressure	Stroke
1	Diamond Stone No: 11373-30-07 + Brush Remove wear edge in the top	25 m/min	50 %	NONE
2	Diamond Stone No: 11373-30-07 Rough honing the entire running surface	25 m/min	50 %	AUTO
3	Ceramic Stone No: 11373-20-39 Creating surface structure	25 m/min	50 %	AUTO
4	Ceramic Stone No: 11373-20-36 Creating final plateau honing	25 m/min	25 %	AUTO

In order to ensure throughout cleaning and removal of abrasive particles from the liner surface after the honing procedure, we recommend to perform the honing with the liner dismantled from the engine frame. This will prevent contamination of the lube oil sump with abrasive particles.

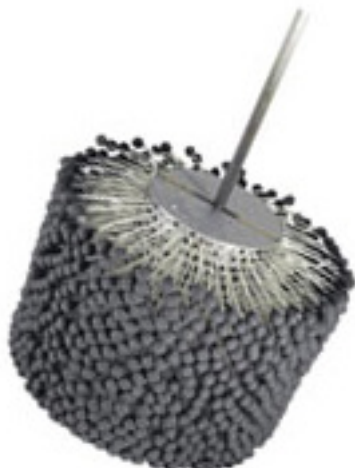
With the above update, the honing brush previously delivered with the engine’s standard tools will no longer be included in the standard tool set.

The honing brush is no longer supplied with the standard tool set for the engine.
